**CEDD SERVICE CONTRACT NO. WD/07/2022**

**YUEN LONG SOUTH FIRST PHASE DEVELOPMENT -  
ENVIRONMENTAL TEAM**

**MONTHLY ENVIRONMENTAL MONITORING AND AUDIT  
REPORT – SEPTEMBER 2024**

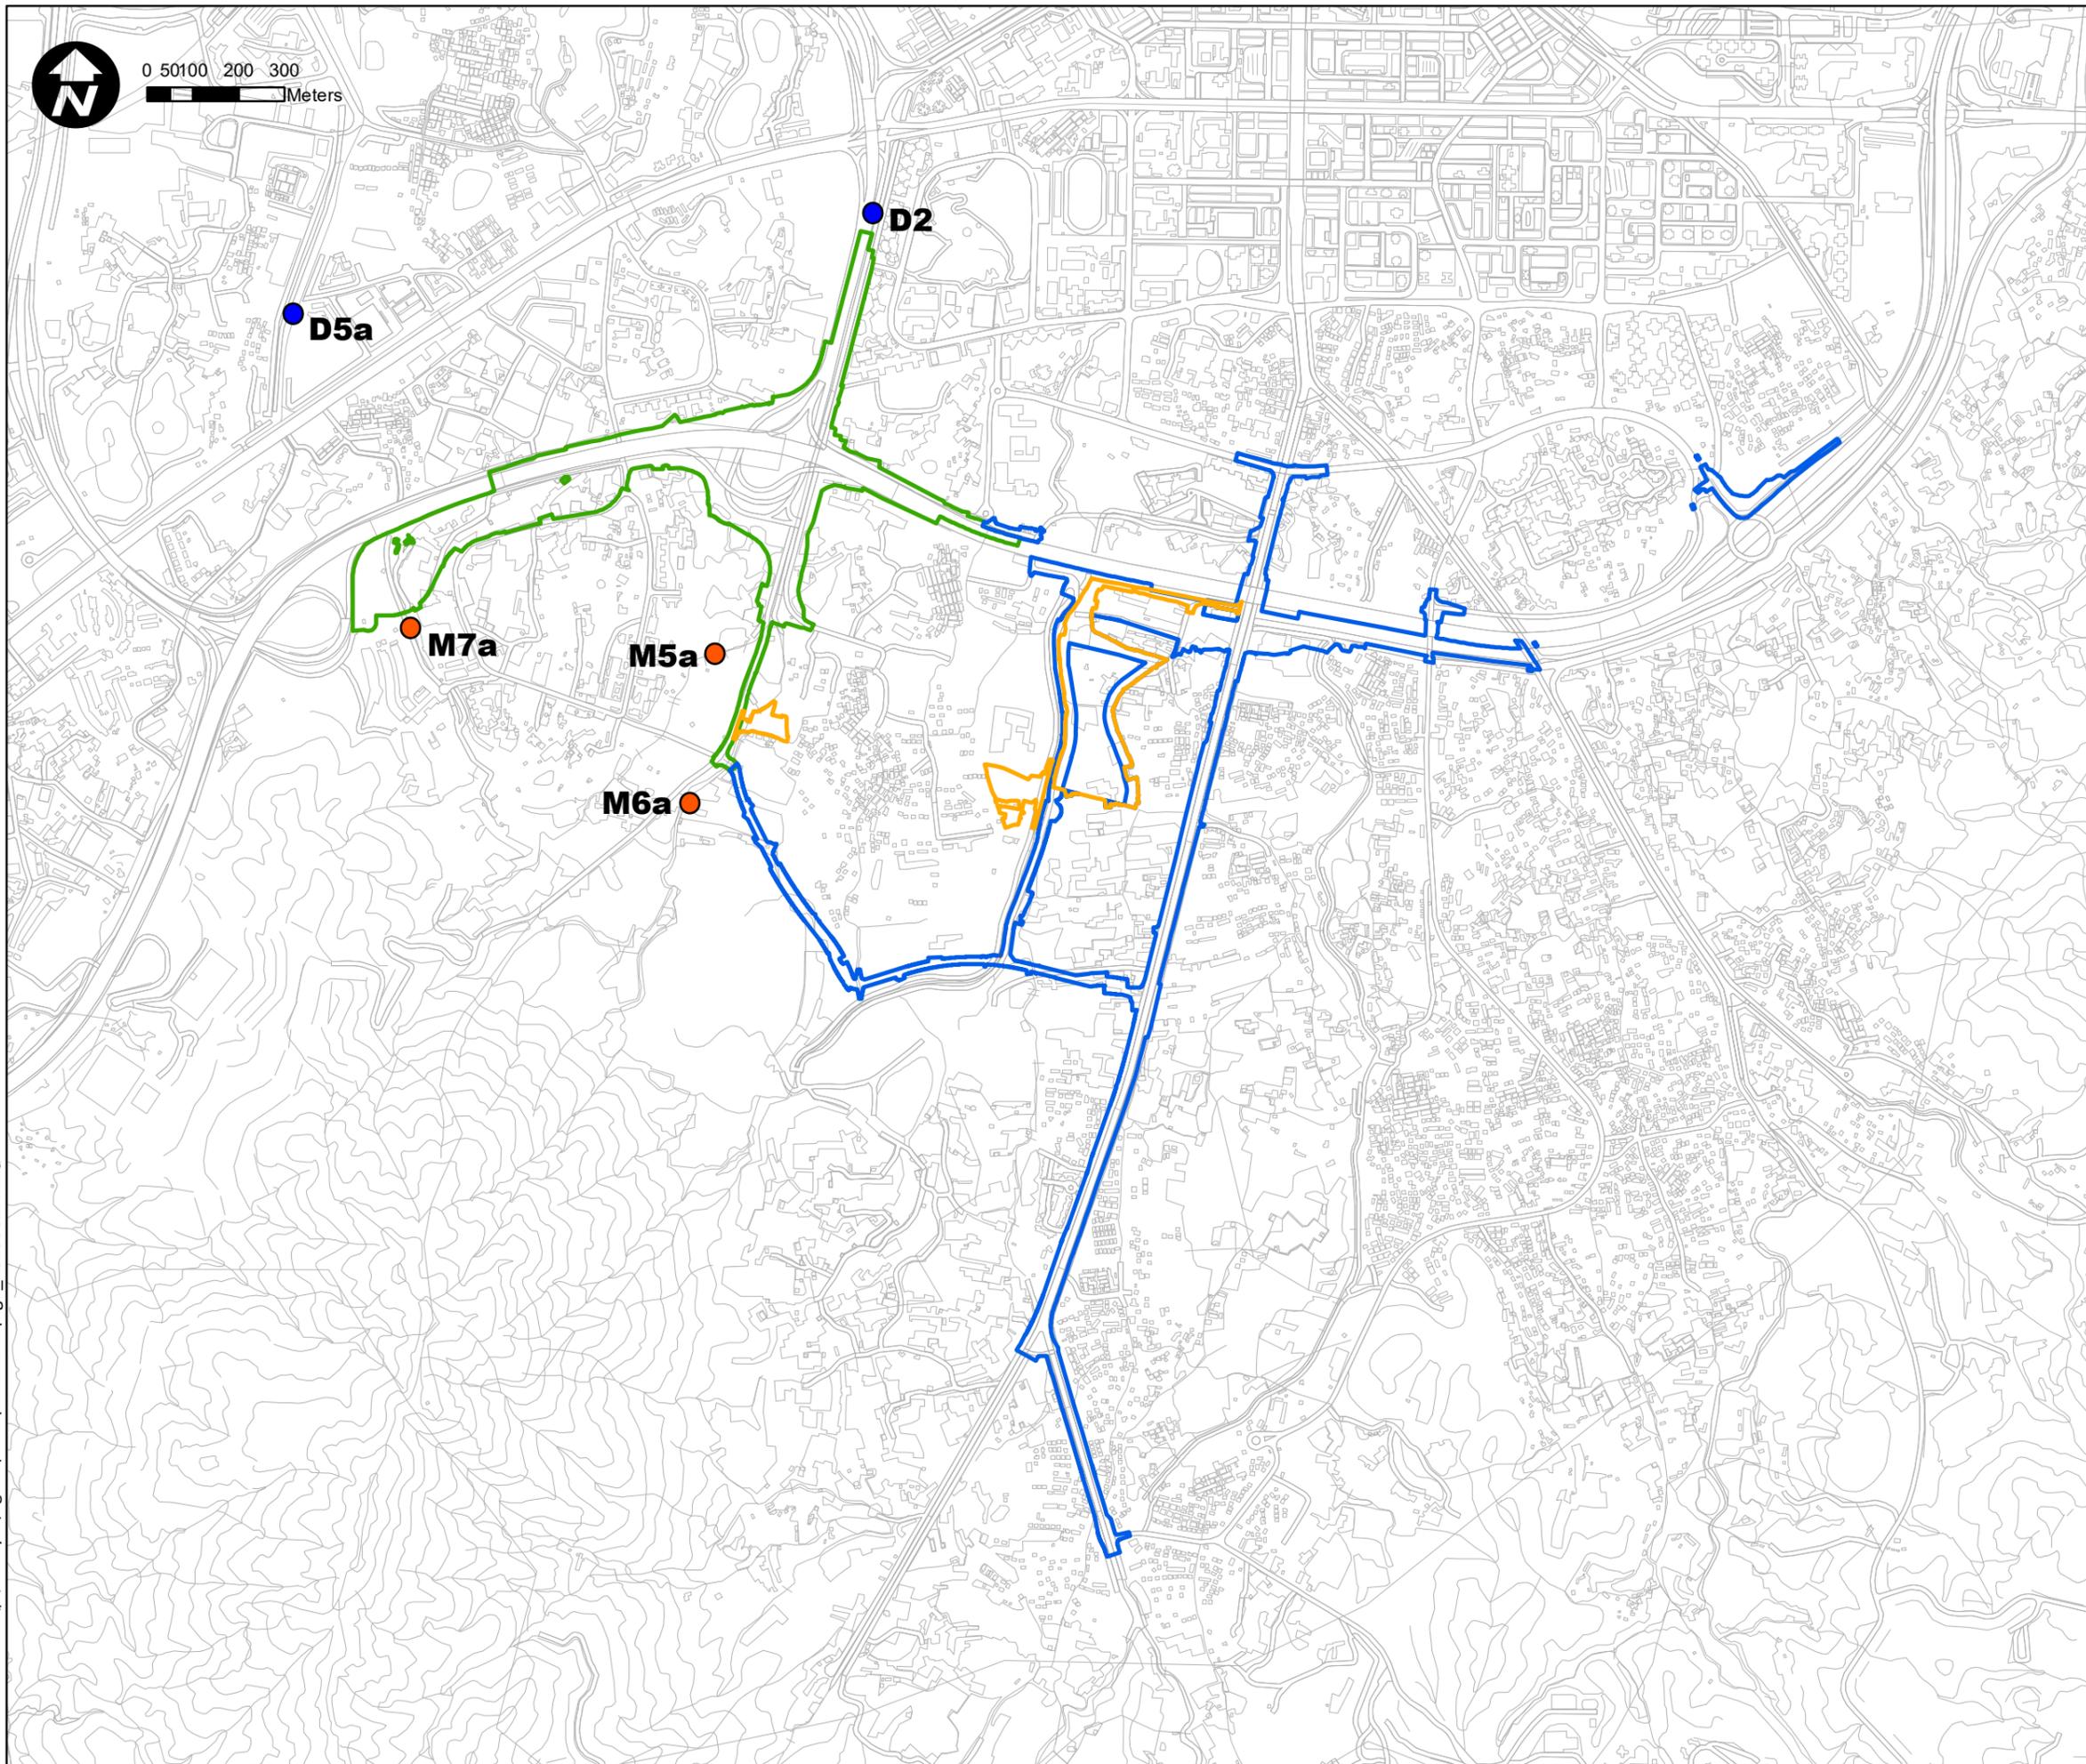
Figure Title:  
**Location of Water Quality Monitoring  
Stations for Contract 2**

- Boundary of YL/2021/03 (Contract 1)
- Boundary of YL/2021/04 (Contract 2)
- Boundary of YL/2022/01 (Contract 3)
- Water Quality Monitoring Impact / Gradient Stations
- Water Quality Monitoring Control Stations

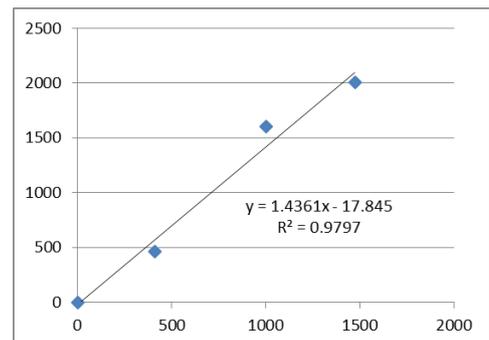
Correlation Coefficient (R) 0.9898

- Strong** Correlation ( $R > 0.8$ )
- Factor 1.4361 (µg/m<sup>3</sup>)/CPM should be apply for TSP monitoring

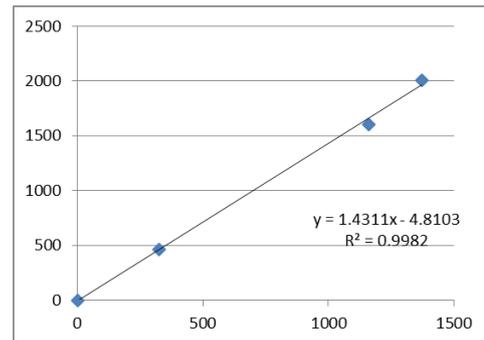
Correlation Coefficient (R) 0.9990

- Strong** Correlation ( $R > 0.8$ )
- Factor 1.4311 (µg/m<sup>3</sup>)/CPM should be apply for TSP monitoring

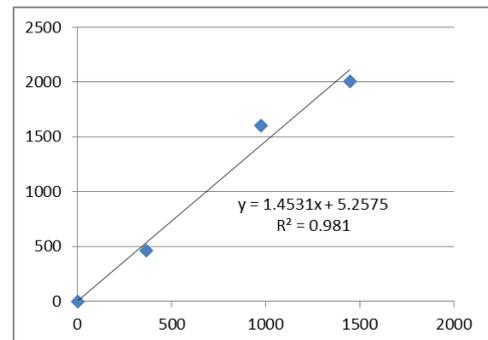
Correlation Coefficient (R) 0.9904

- Strong** Correlation ( $R > 0.8$ )
- Factor 1.4531 (µg/m<sup>3</sup>)/CPM should be apply for TSP monitoring

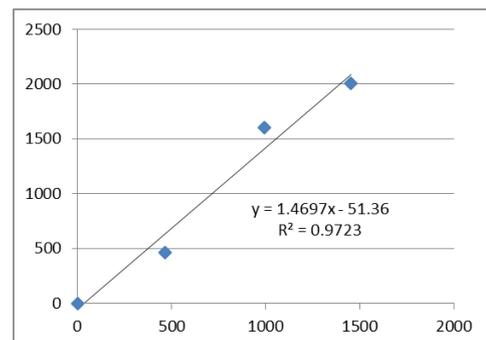
Correlation Coefficient (R) 0.9861

- Strong** Correlation ( $R > 0.8$ )
- Factor 1.4697 (µg/m<sup>3</sup>)/CPM should be apply for TSP monitoring
